# Sample Home Inspection Report

## **Sample Property Woodinville, Washington**

Prepared for:  
Christopher White  
RE/MAX Metro Eastside

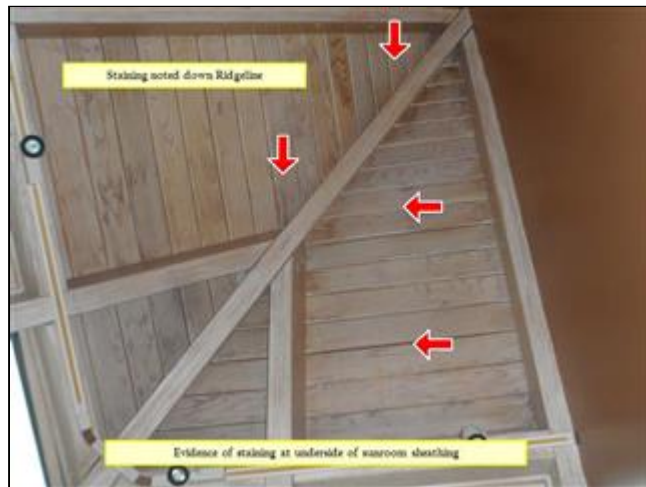
1.0 Picture 1

**1.0 (1)** Most of roof covering has algae/mildew buildup and some Moss growth at North end. There is visible evidence of staining at the underside of roof sheathing at the interior of sunroom- *undetermined if this is from the previous roof or an active roof leak - no signs of moisture at time of inspection, conditions have been dry for some time; **Recommend a licensed roofing contractor to service roof, remove algae, check for leaks and issue a five year warranty at their discretion.***

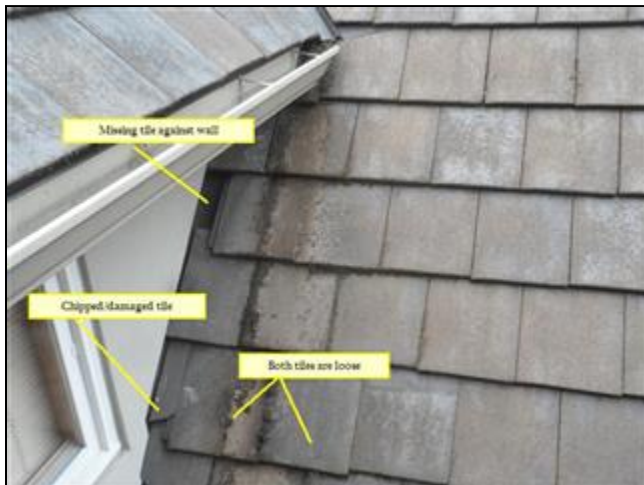
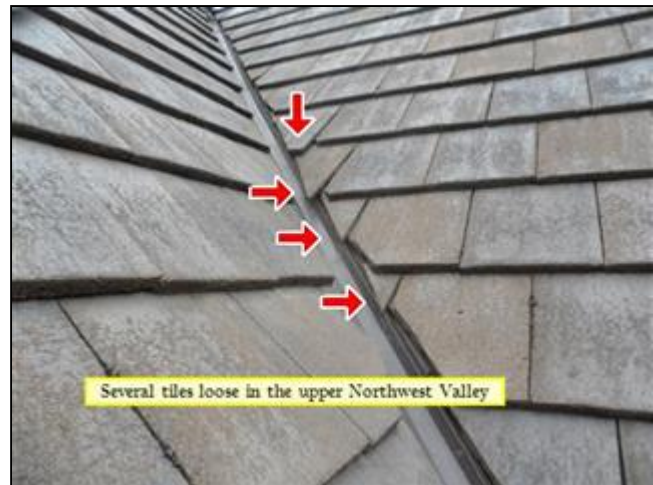
**1.0 (2)** Several tiles are loose/fallen or chipped/damaged. 1/3 of a tile is missing against lower North West wall above garage; **Recommend a qualified roofing contractor to repair/replace damaged tile and secure loose tile.**

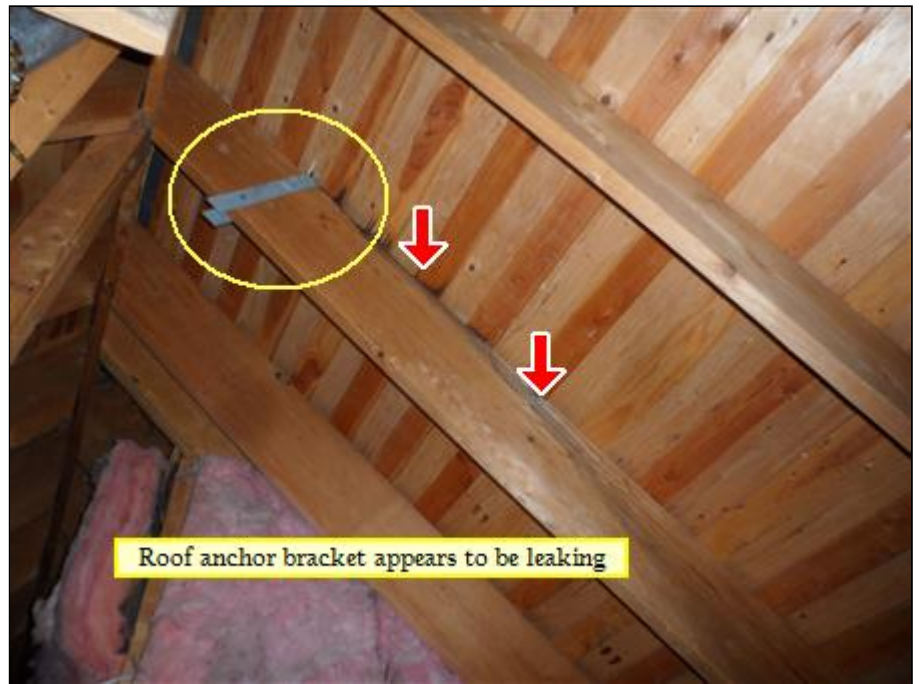
1.0 Picture 4

**1.0** (3) Evidence of staining around South roof anchor bracket - no visible evidence of a storm boot present; ***Recommend a licensed roofer to evaluate and repair leak/install storm boots over anchors where missing.***

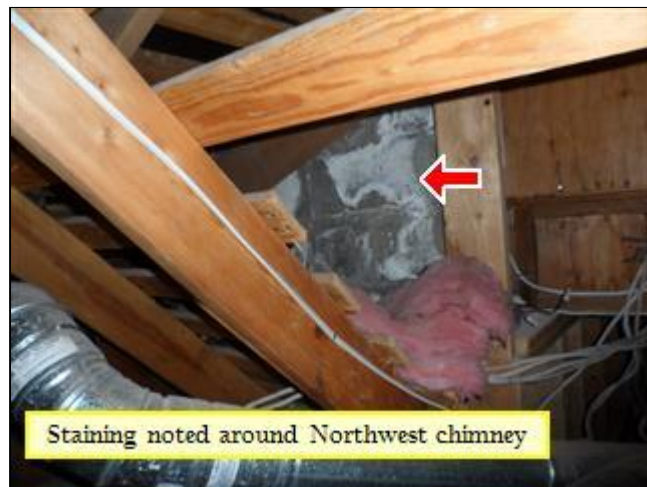
1.1 Picture 1

**1.1** Efflorescence staining detected around northwest chimney from garage attic space - indication of leakage; ***Monitor for future leaks during rainy season - Repair by a licensed roofing contractor is recommended if future conditions occur.***

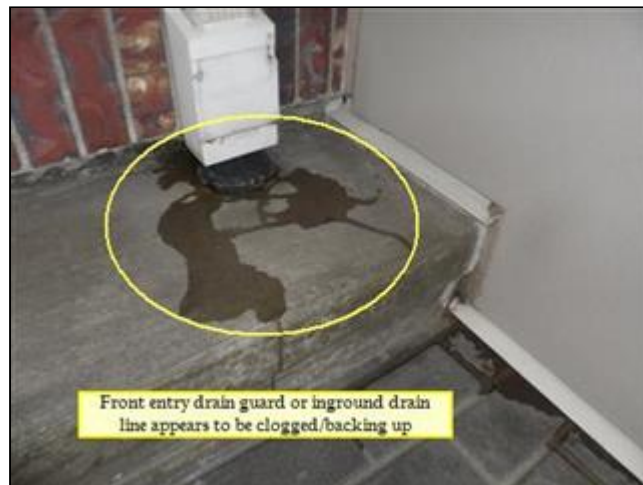
1.4 Picture 1

**1.4** Several Downspouts appear to be backing up or called at the drain guard filters- front downspout is backing up and pooling on front entry stoop; ***Recommend cleaning out filters or unclogging inground drain line to keep from backing up.***

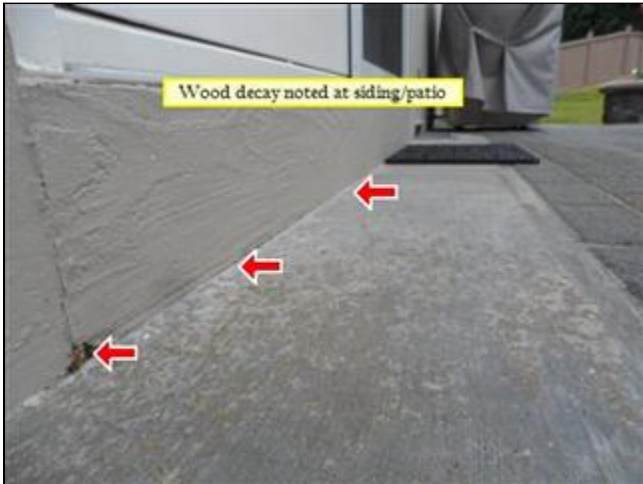
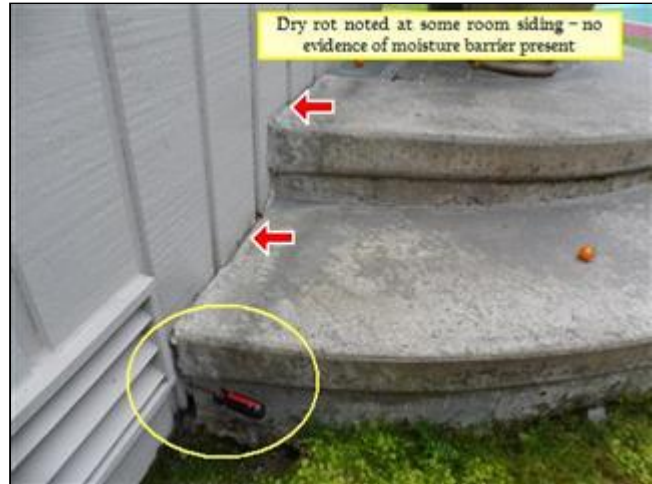
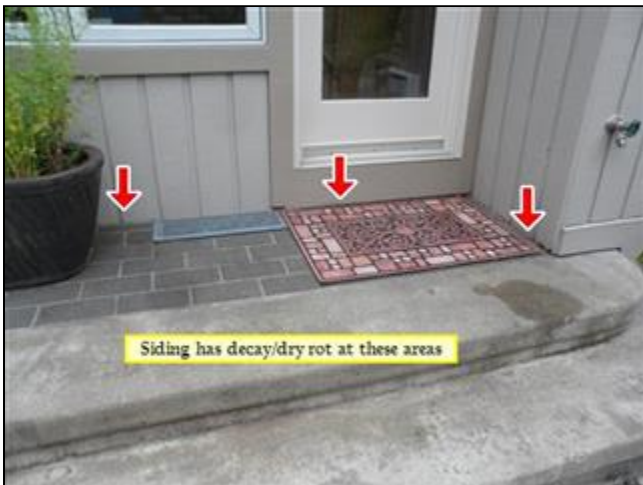
**🏠 2.1 The Southwest sunroom and South wood siding has evidence of deterioration/dry rot where it extends behind concrete stoop/patio- no visible evidence of a moisture barrier present; *Recommend a licensed contractor to repair/replace damaged siding and install proper underlayment/moisture barrier or flashing protection to prevent future conditions.***

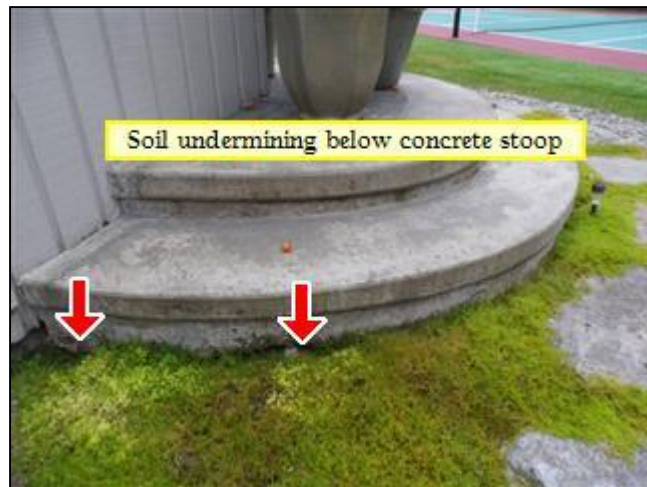
2.5 Picture 2

**2.5 (2) Evidence of soil undermining below the southwest sunroom concrete stoop; ***Repair is recommended to prevent movement to the Stoop.*****

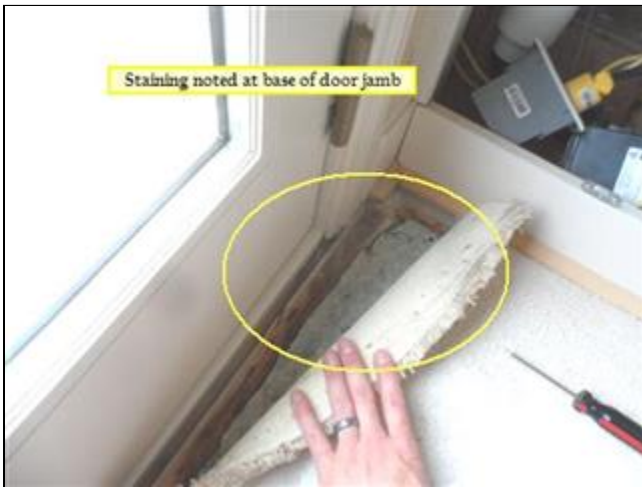
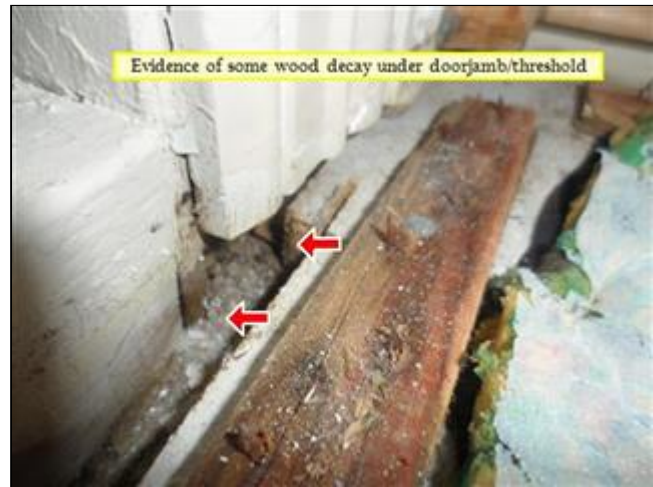
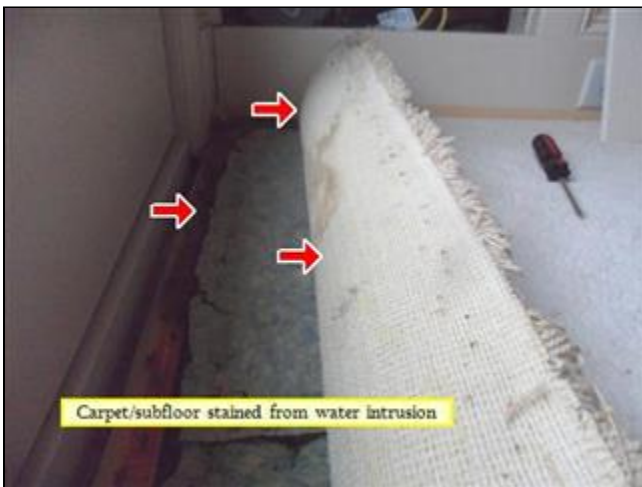
**2.9** (1) There is evidence of staining at the base of master bedroom and balcony entry door jam, at underside of carpet and wood decay under threshold area - indication that moisture is leaking or has leaked through balcony entry doors; ***Recommend a qualified contractor to evaluate and take all remedial action necessary to fully waterproof entry door. Note that I suspect staining to be from a previous leaky door prior to roof overhang installation.***

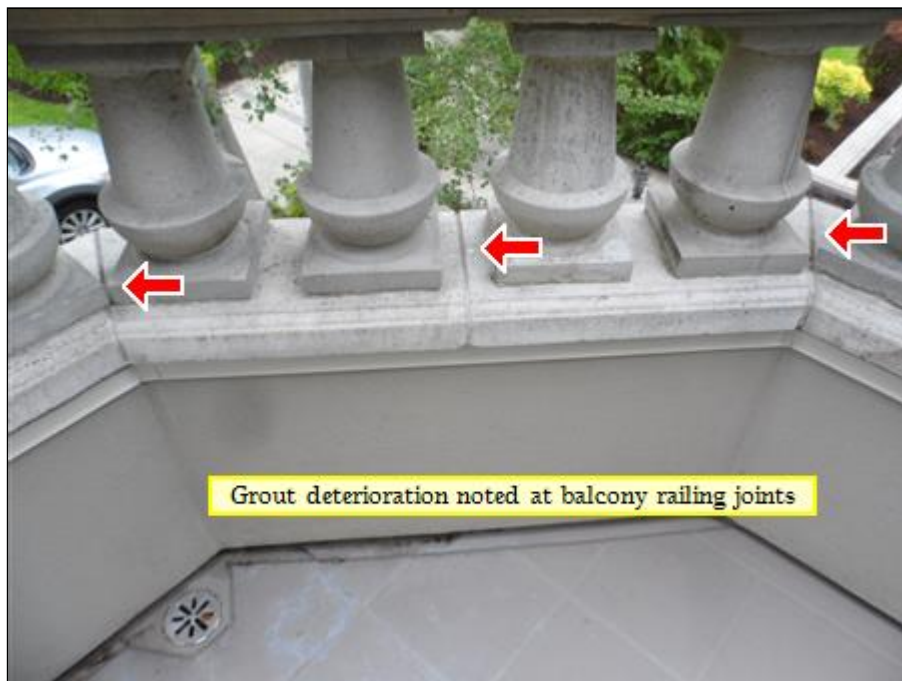
2.9 Picture 4

**2.9 (2)** Grout deterioration noted at North concrete railing joints; ***RegROUT and seal areas where failed to prevent water intrusion/decay.***

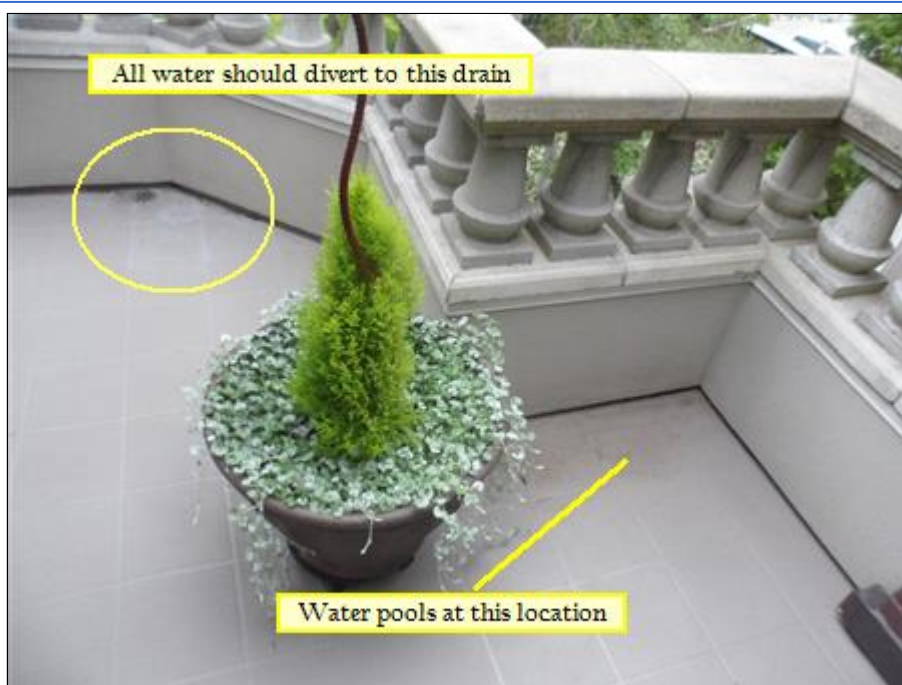
2.9 Picture 5

**2.9 (3)** North balcony pools water at East side; ***Consult a qualified contractor to evaluate and repair pitch to divert storm water to drain as needed.***

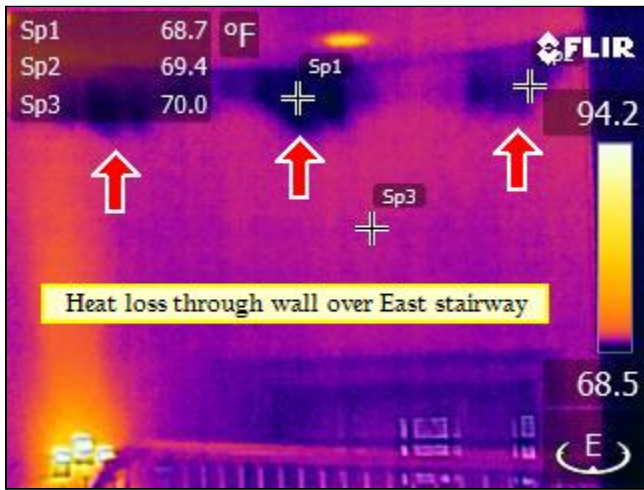
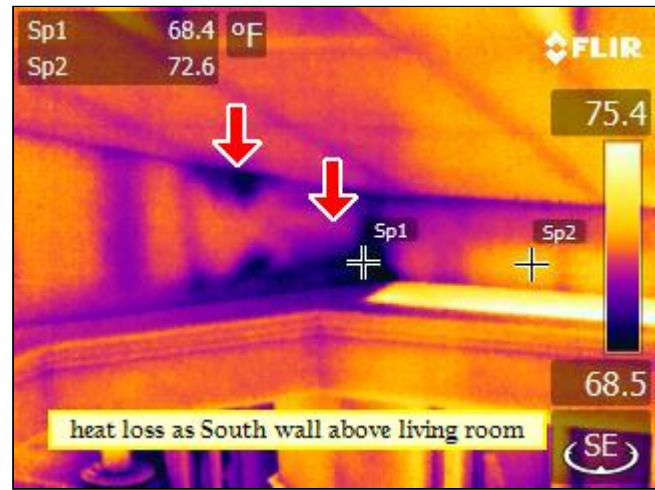
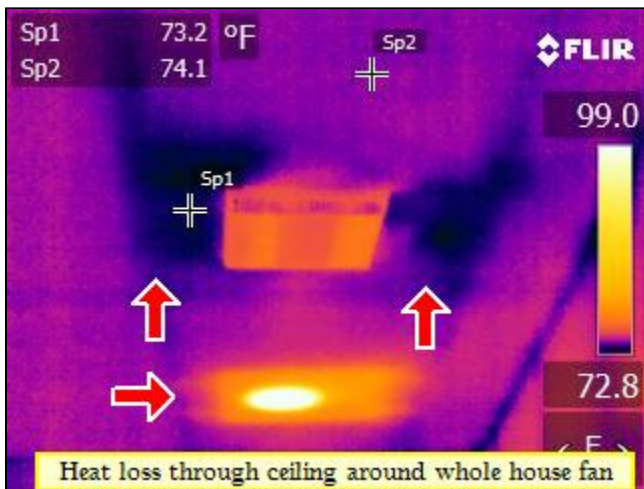
**3.2** Insulation levels have settled over the years reducing the overall heat efficiency of home- cold spots also detected at multiple wall areas; ***Recommend a qualified insulation company to re-blow loose fill fiberglass insulation to meet/exceed R-50 rating to improve heat efficiency of home.***

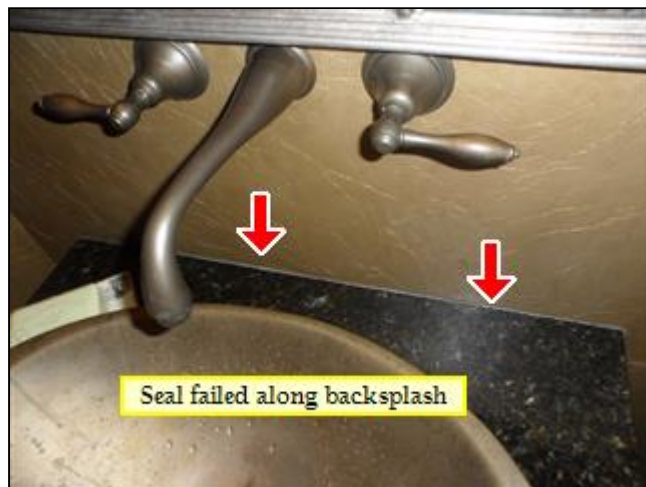
5.9 Picture 1

**5.9 (2)** Back splash seal is failed behind half bathroom sink to wall; ***Recommend applying seal at areas where failed.***

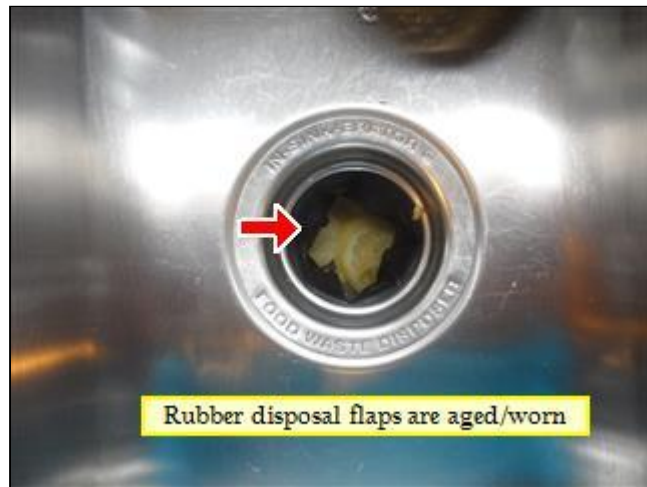
6.2 Picture 1

**6.2** RUBBER FLAPS TO DISPOSAL DRAIN ARE AGED/ WORN AND CAN ALLOW OBJECTS TO FALL INTO DISPOSAL; ***REPLACE FLAPS FOR SAFETY TO KEEP OBJECTS FROM FALLING INTO DISPOSAL DRAIN FOR SAFETY.***

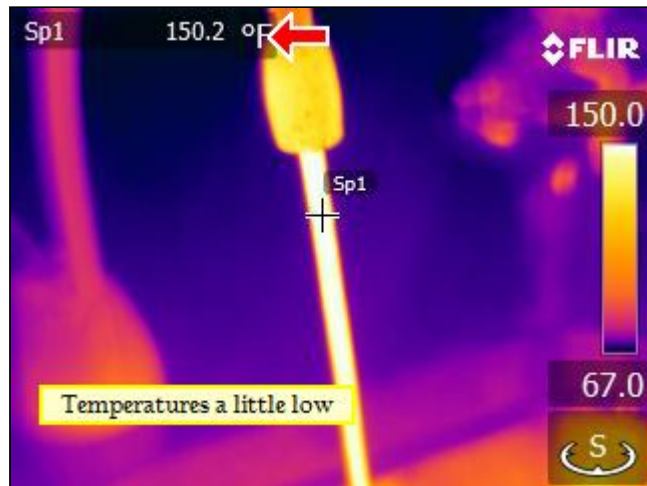
6.10 Picture 1

**6.10** Use caution when using the instant hot water dispenser - temperatures are currently at 150° and a little low; ***Adjust to 165° ± as needed.***

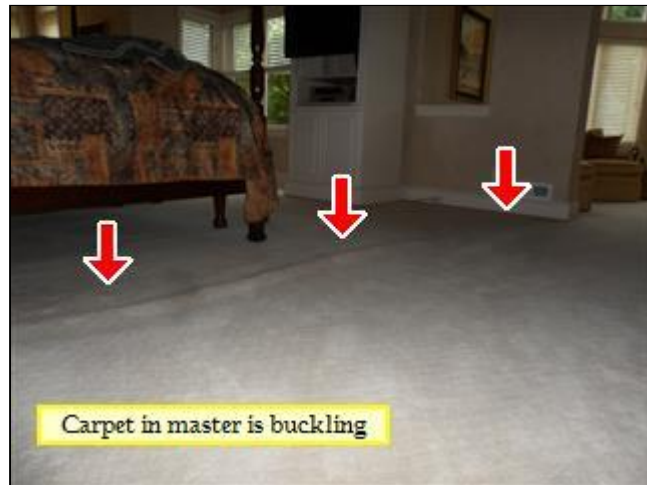
7.2 Picture 1

**7.2** Carpet in master bedroom is bunched up at several locations; ***Recommend a qualified contractor to stretch out carpet to prevent trip hazards.***

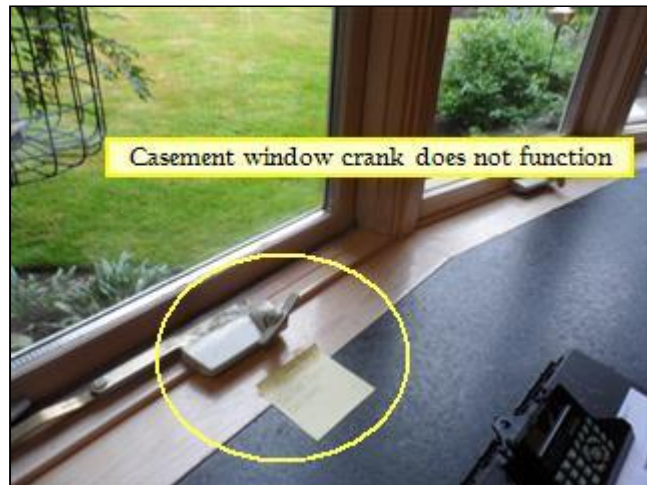
7.4 Picture 1

**7.4** Left casement window behind kitchen sink has a broken handle which the owner has disclosed and is a work in progress; ***Verify functionality prior to closing as needed.***

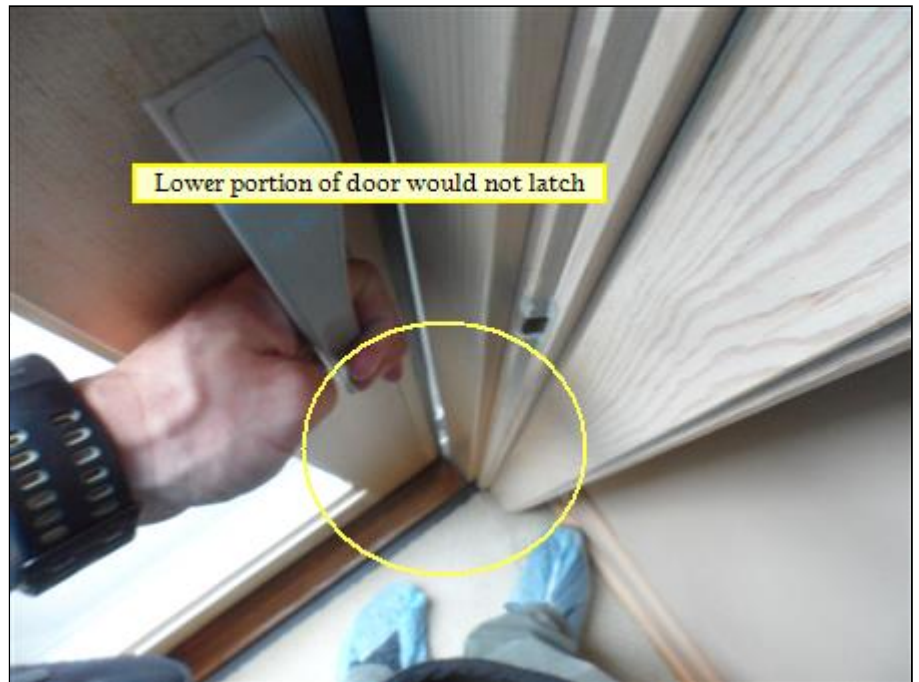
7.5 Picture 1

**7.5** (1) Locking mechanism to the master bedroom and balcony entry door would not engage when the doors closed - reasons undetermined; ***Recommend a qualified contractor to repair as needed.***

**7.5 (2)** Lower locks to the North guest bedroom balcony entry door would not engage or latch; ***Recommend a qualified door contractor to adjust/repair.***

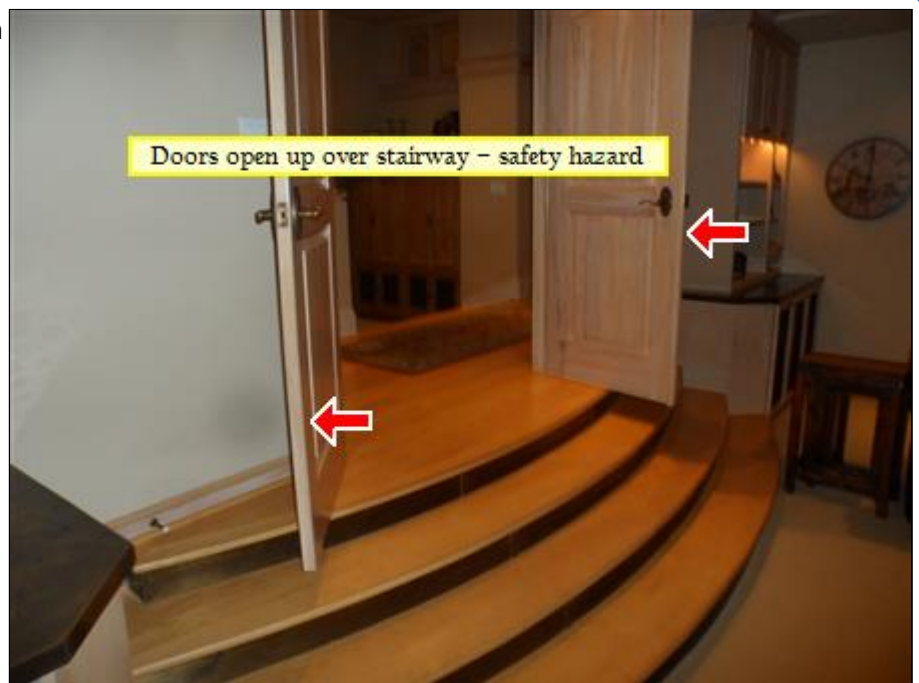
7.5 Picture 2

**7.5 (3)** French entry doors open up over stairway to the game room - safety hazard; ***Recommend installing pocket doors or reinstall doors to open toward hallway for safety.***

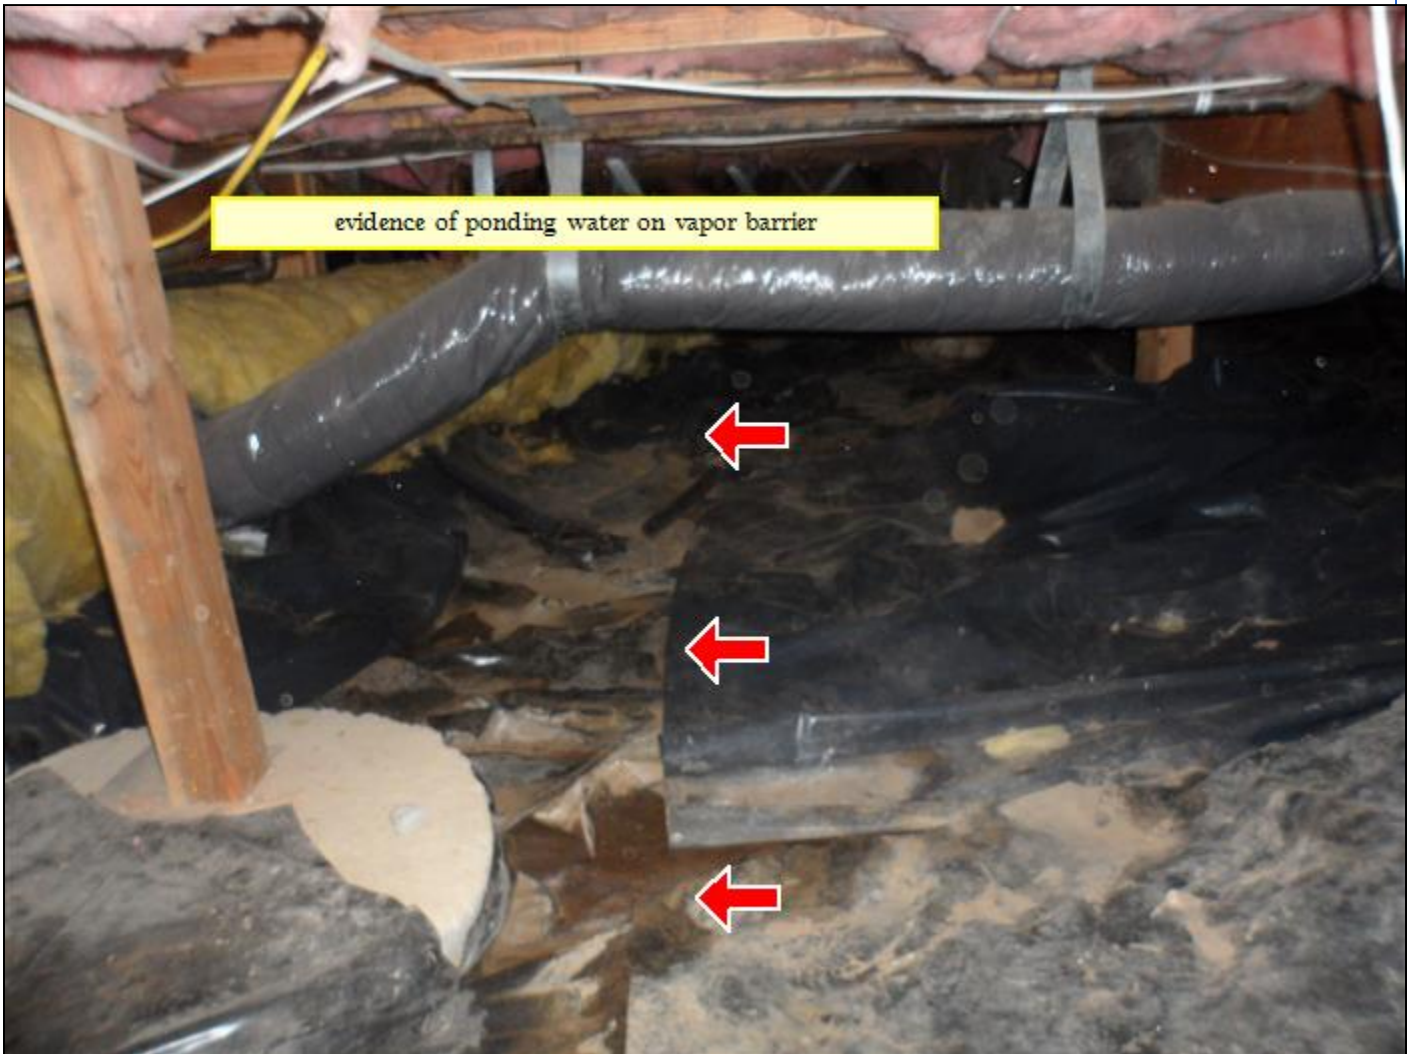
8.6 Picture 1

🏠 **8.6 Evidence of staining/water penetration detected at multiple footings/foundation walls. Vapor barrier has staining and evidence of ponding/standing water toward Central area of home. Soil is also damp/soft under vapor barrier on the first day of August during dry seasons. Note that the exterior grade is level and/or slopes toward home which is conducive to water penetration in substructure; *It is my recommendation that a licensed and bonded drainage contractor should evaluate, determine actual cause of existing moisture under home and take all remedial action necessary. Note that there are multiple remedies that could be applied to this condition and should be verified by the specialist.***

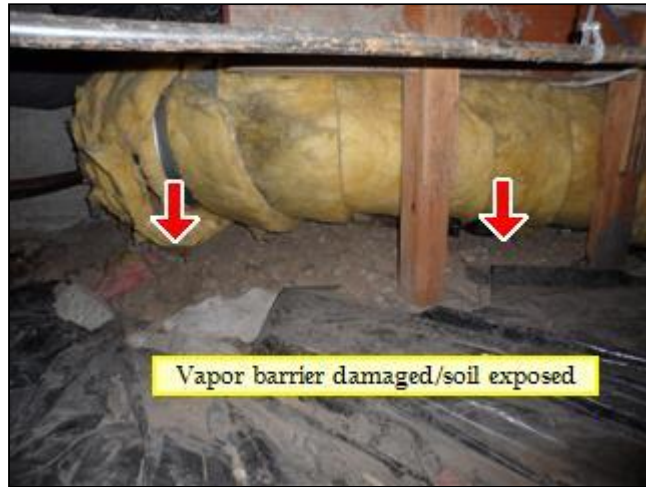
8.9 Picture 1

**8.9** Soil is exposed at approximately 15% of overall crawlspace, vapor barrier is damaged from age and/or water intrusion; ***Recommend a qualified contractor to replace vapor barrier at time of waterproofing substructure/drainage repair.***

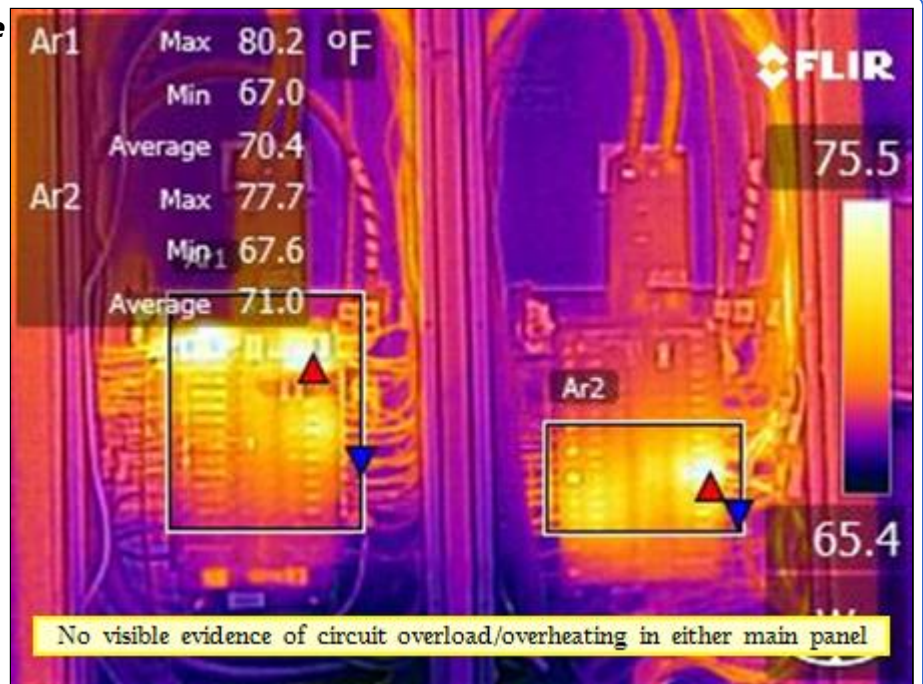
9.1 Picture 1

**9.1** *There is no visible evidence of circuit overload in the main panel at breaker/wire contacts at time of inspection. All available electrical devices were simultaneously turned on at time of inspection with an approximate 10 min. amperage load - there were no conditions detected.*

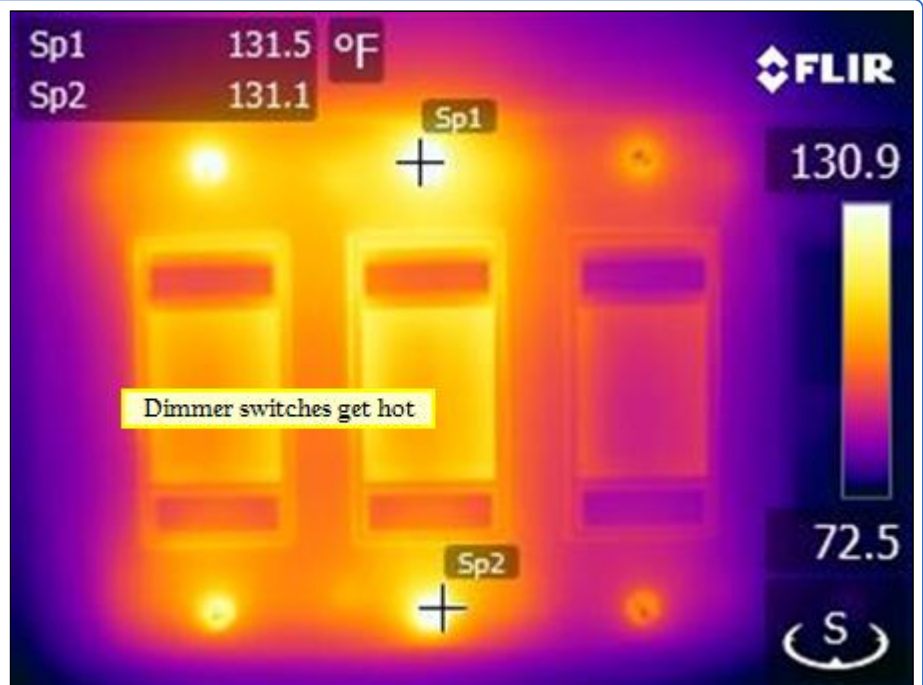
9.3 Picture 1

**9.3** (1) Dimmer switch to the front entry/stairway lights reached temperatures over 130° and is a little high; **Consult a licensed electrician to evaluate and reduce light bulb wattage or upgrade dimmer as needed.**

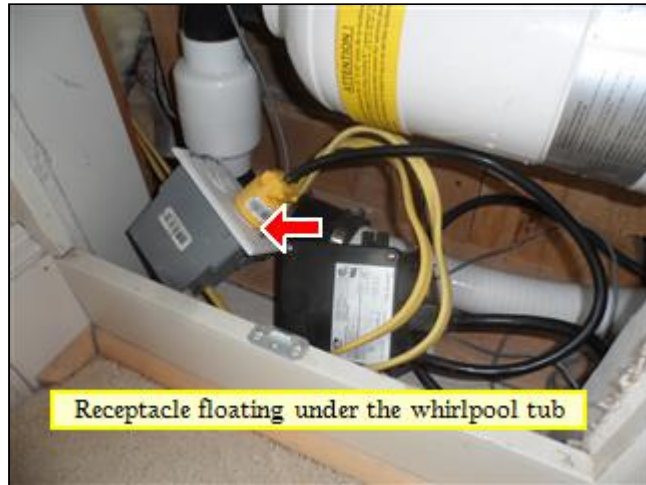
9.3 Picture 2

**9.3** (2) Receptacle to the whirlpool tub under master bathtub is floating/unsecured; ***Recommend securing receptacle for safety.***

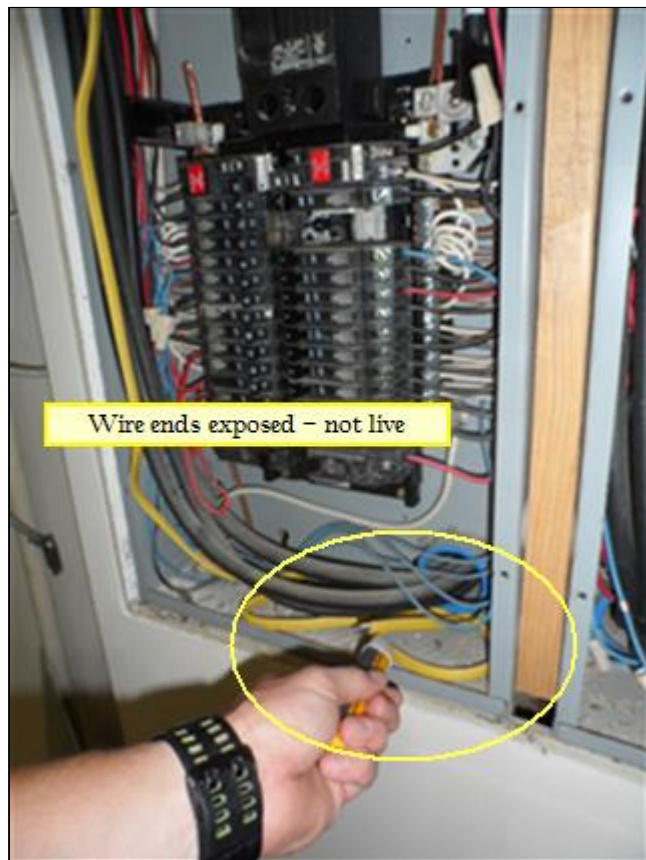
9.4 Picture 1

**9.4** (1) Romex wire in the left main panel is floating with exposed wire ends and wiring is not in use- Not live; ***Recommend a licensed electrician to install wire nuts or remove/finish installation for safety.***

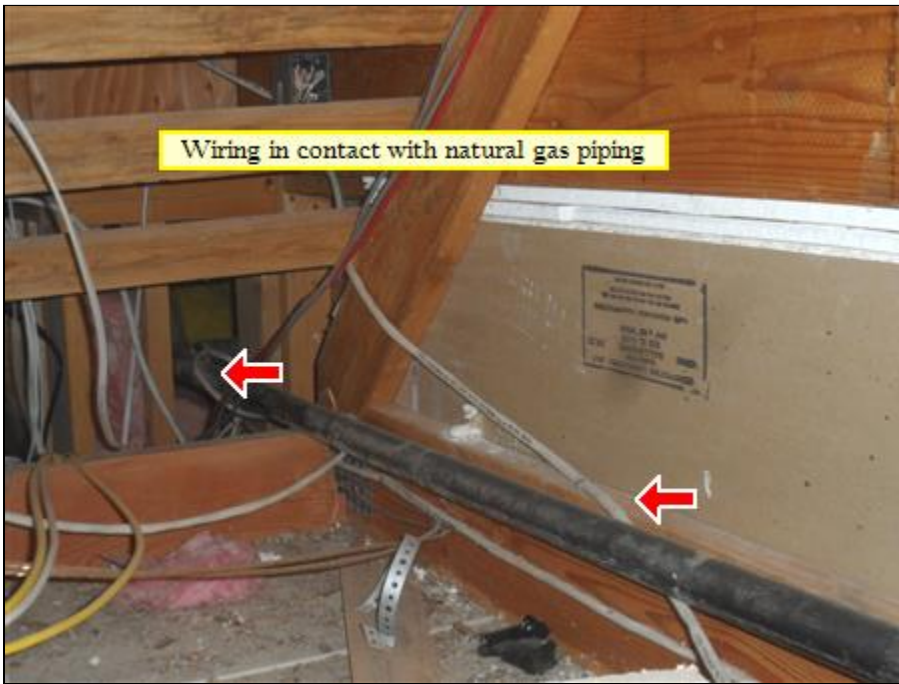
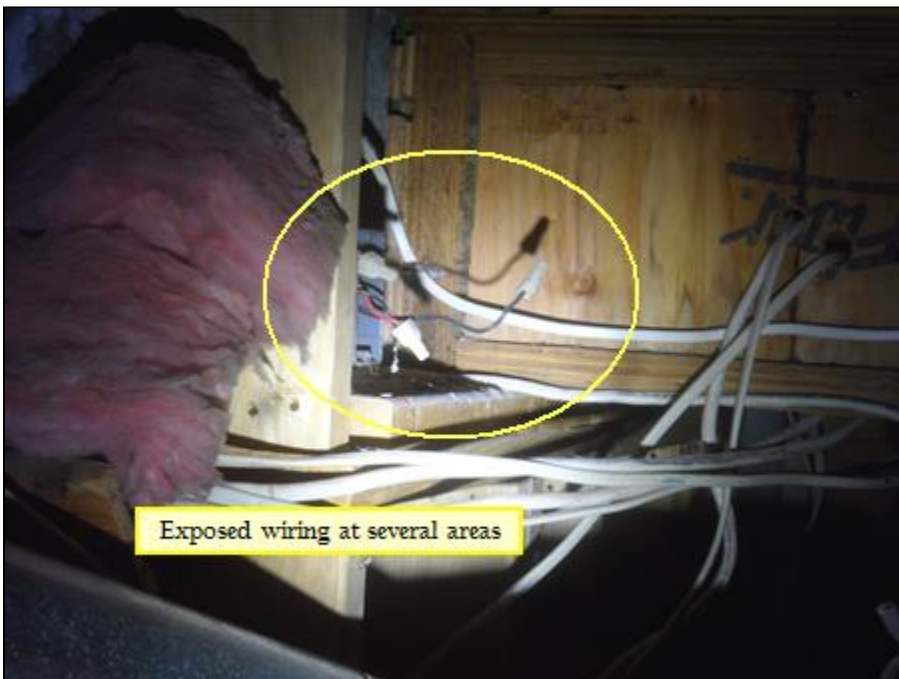
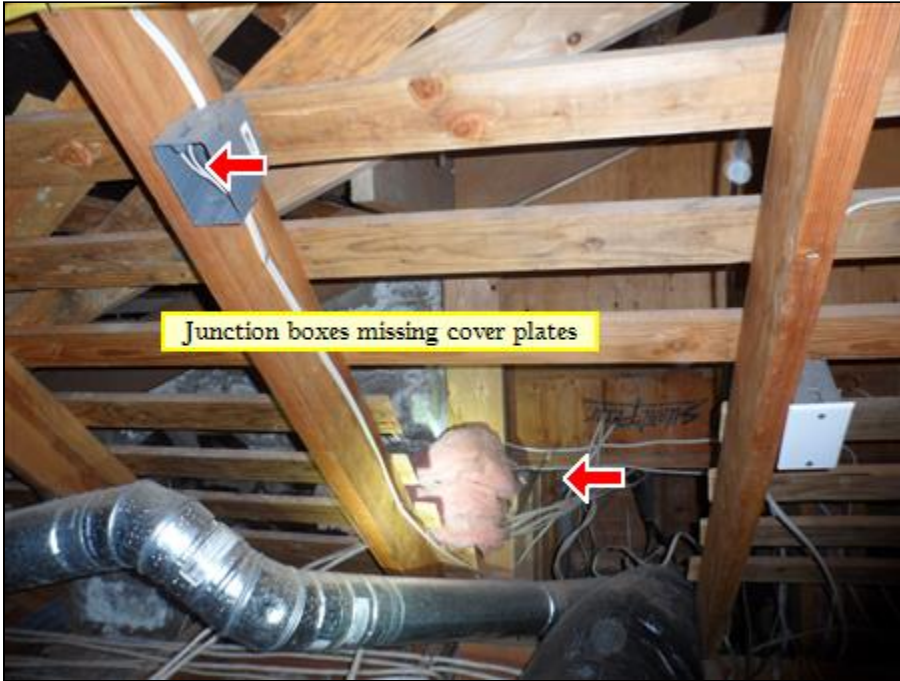
🏠 9.4 (2) Multiple junction boxes in the garage attic space are missing covers exposing the wires, several wire raceways are sloppy and in contact with natural gas plumbing, several wires are unfinished with exposed wire ends; ***Recommend a licensed electrical contractor to evaluate, reroute wire raceways with proper clearances from plumbing/gas lines, finish exposed wires and install covers over junction boxes where missing for safety.***

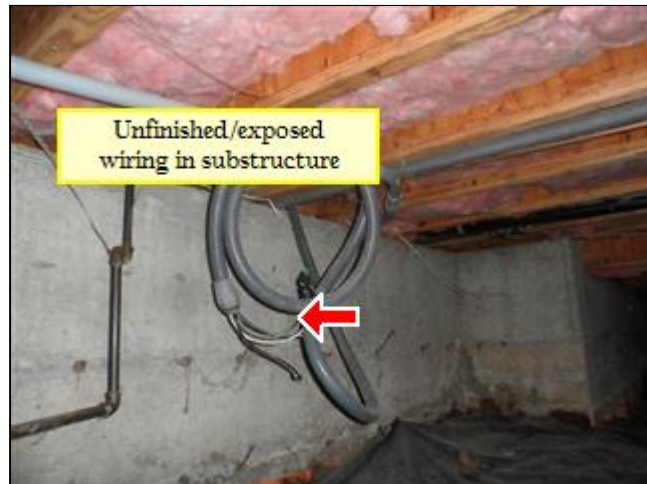
9.4 Picture 5

**9.4 (3)** Unfinished wiring dangling/left in Southwest portion of substructure; ***Remove finish wiring installation as needed for safety - I suspect this is intended for a hot tub.***

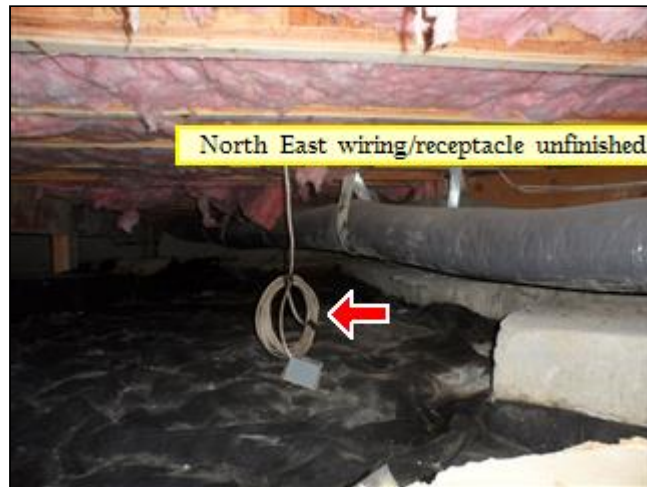
9.4 Picture 6

**9.4 (4)** Additional unfinished wiring hanging from the Northeast floor joists in crawlspace;  
***Recommend a licensed electrician to finish wiring installation or remove for safety.***

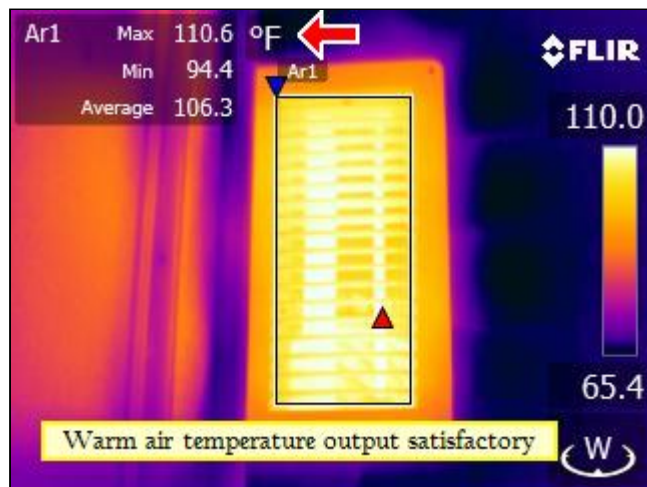
10.0 Picture 1

**10.0** Both Furnaces (attic/ garage) function satisfactorily at time of inspection but are 14+ years old and at/near the end of their design life; **Recommend a qualified heating contractor to service both furnaces and check heat exchangers for any evidence of cracking. Clean out electronic air filters and vacuum ductwork as needed if this has never been done.**

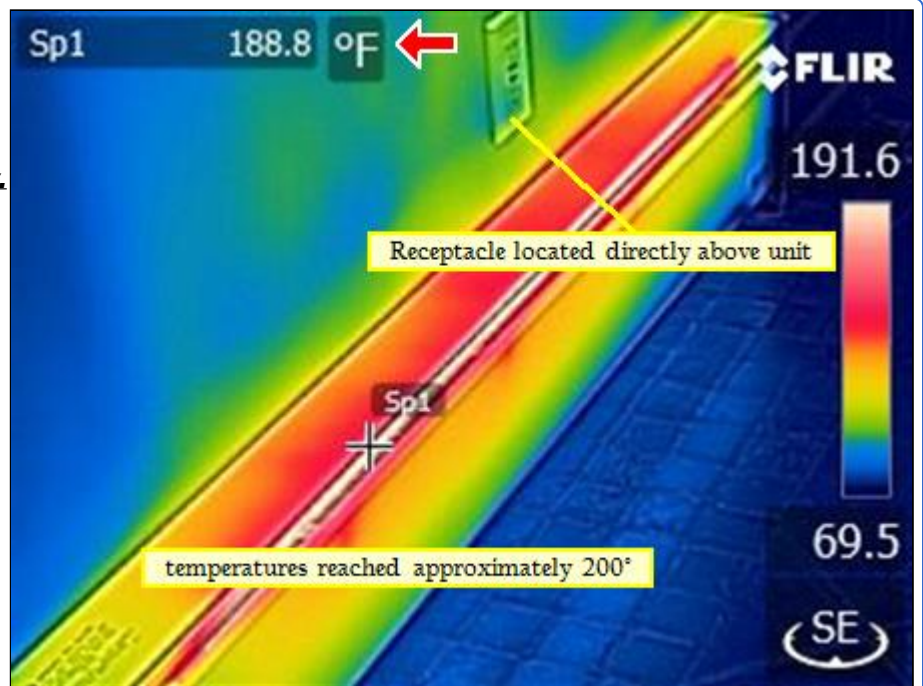
10.1 Picture 1

**10.1** Closed hot water circulating baseboard heater in sunroom is located directly below a 110 V receptacle; **Recommend relocating receptacle for safety.**

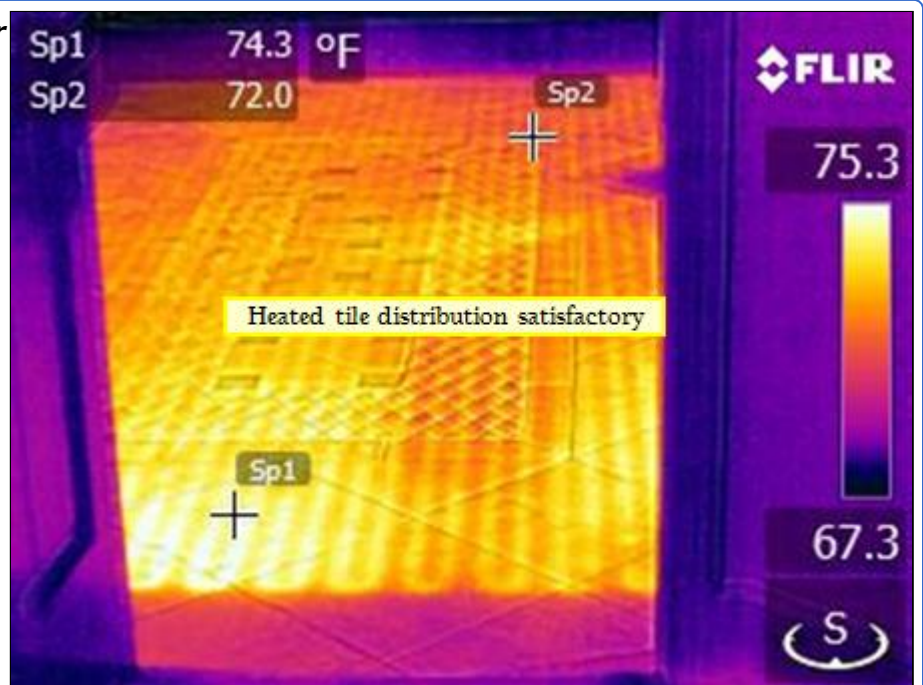
10.2 Picture 1

**10.2** Heated tile floor in master bathroom appears satisfactory

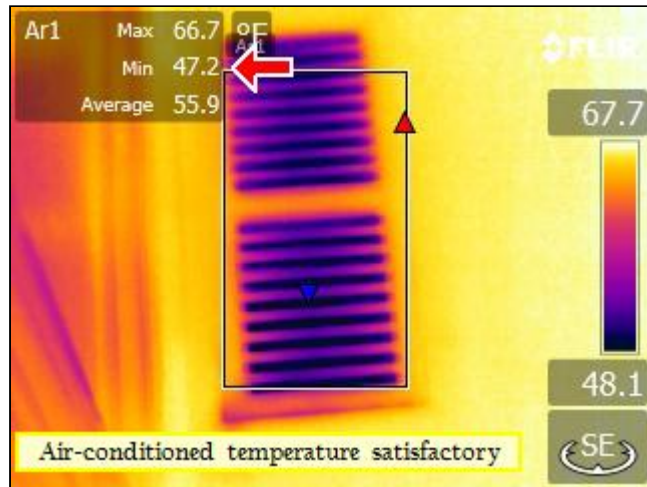
10.12 Picture 1

**10.12 Air conditioner functions satisfactorily at time of inspection and should be serviced at time of furnace service.**

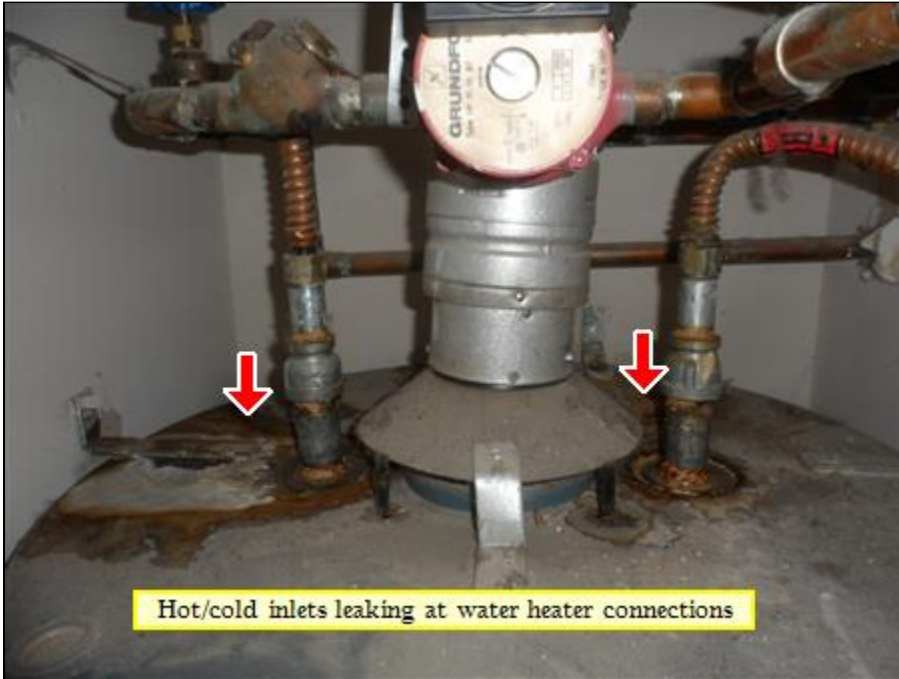
11.0 Picture 1

🏠 **11.0** Water heater is 14 years old and approximately 4 years beyond it's design life. Both the hot and cold inlets have excessive corrosion and/or leaking upon entrance of the water heater. There is also rust/corrosion on the outer lining of tank above combustion area, staining noted under water heater. Further note that it took approximately 30+ seconds for hot water to reach the kitchen faucet - indication that the circulator pump may not be functioning properly; ***Recommend a qualified service technician to replace water heater, service/repair or replace circulator pump and install an overflow pan. Note that if the water heater develops a large leak it could potentially come back into the home.***

Hot/cold inlets leaking at water heater connections

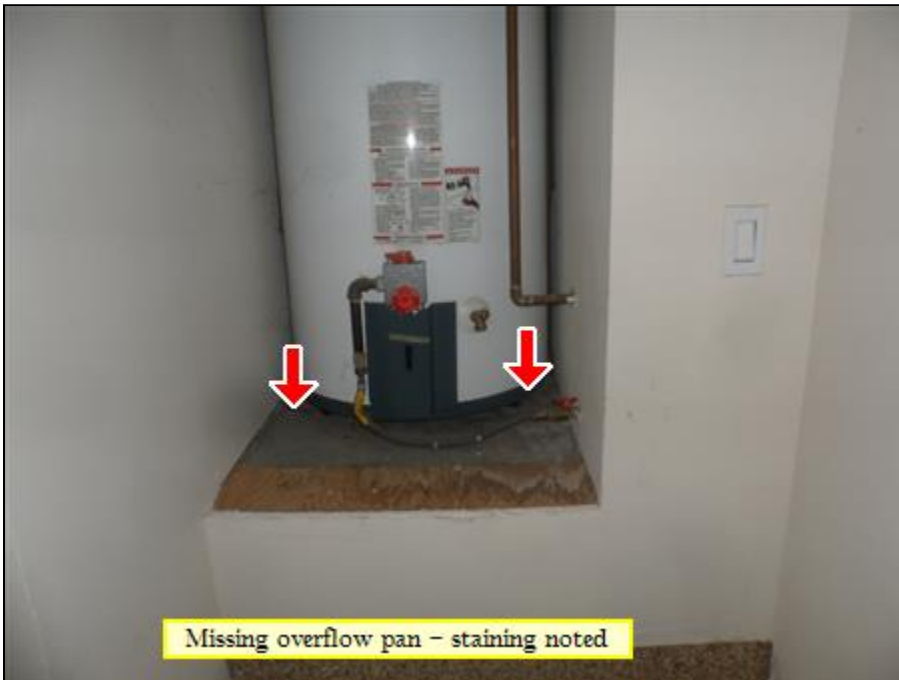
11.0 Picture 2

Missing overflow pan - staining noted

**11.5** NO OVERFLOW PAN HAS BEEN INSTALLED UNDER WATER HEATER; ***RECOMMEND A QUALIFIED TECHNICIAN TO INSTALL AN OVERFLOW PAN IN ORDER TO PREVENT FLOODING IN HOME.***

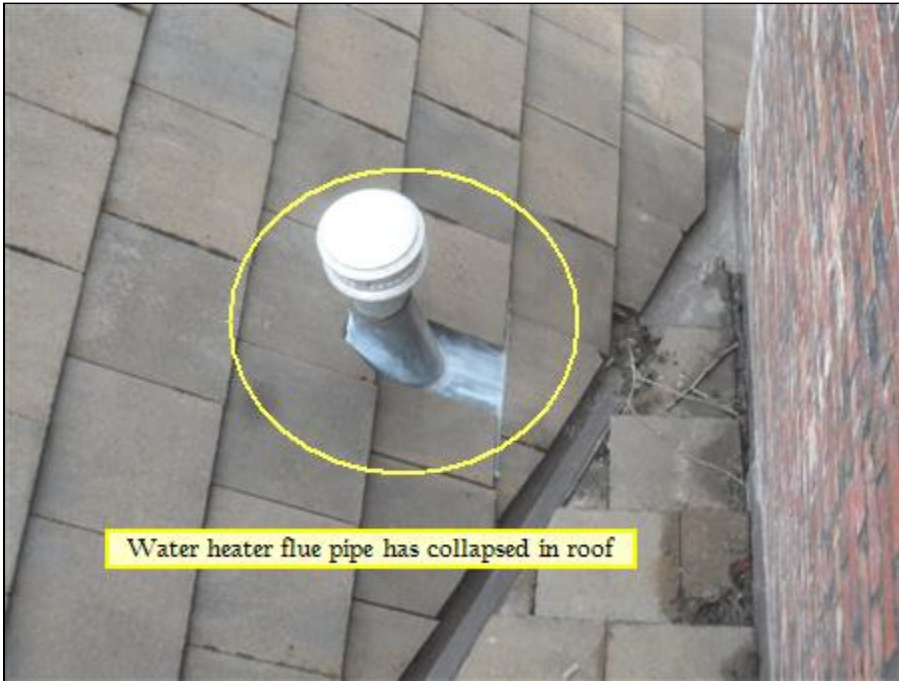
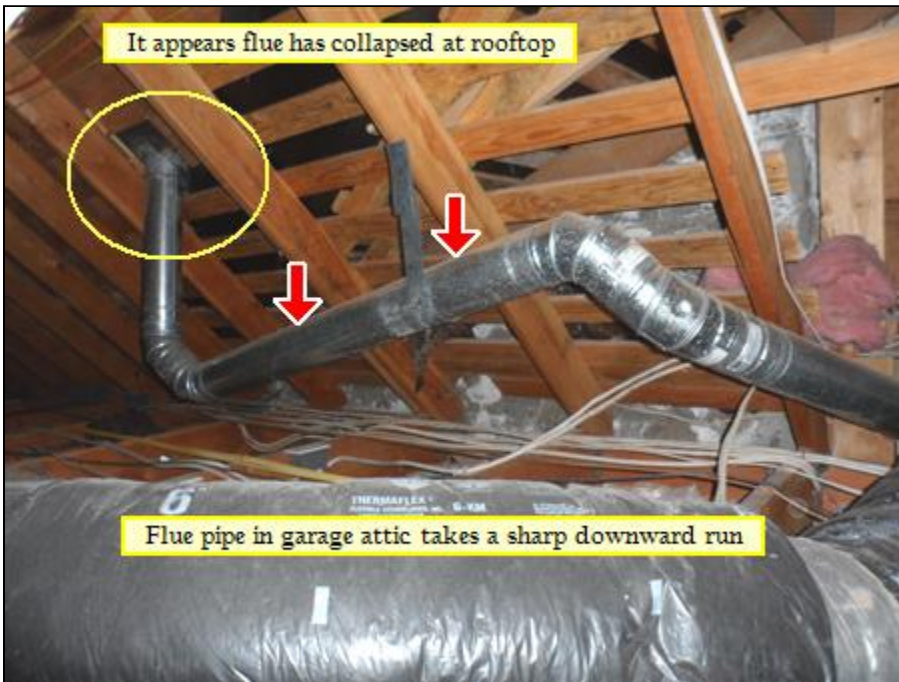
🏠 **11.2** Flue pipe to the natural draft water heater appears to have collapsed in the garage attic space. Flue takes a sharp downward run in attic space and appears to short at rooftop; ***Recommend a qualified contractor to reinstall flue pipe to have an upward run for safety, install additional support straps.***
