# Sample Home Inspection Report

## **Sample Property Woodinville, Washington**

Prepared for:  
Christopher White  
RE/MAX Metro Eastside

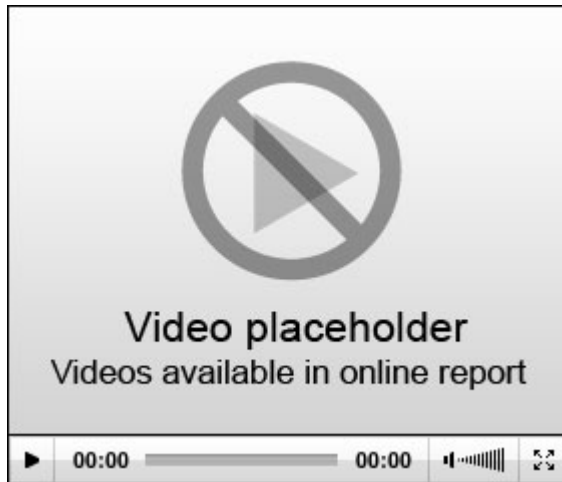
12.1 Picture 1

**🏠 12.1 Metal pipe hangers were used to hang copper plumbing in substructure and have created an electrolysis resulting in corrosion at multiple metal to metal contacts. Excessive leakage detected to the West copper plumbing near crawlspace access - water streaming out of insulation; *Recommend a licensed plumber to replace existing hangers with a noncorrosive material - repair/replace corroded/leaky plumbing.***

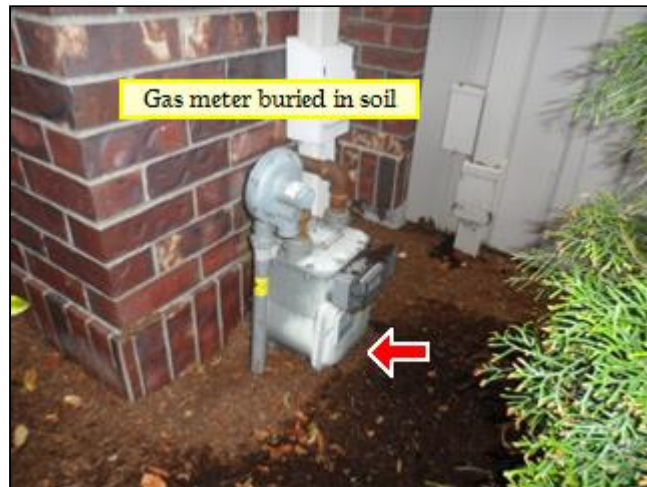
12.2 Picture 1

**12.2** Gas meter is buried in soil;  
**Grade soil a minimum of 6 inches below bottom of meter.**

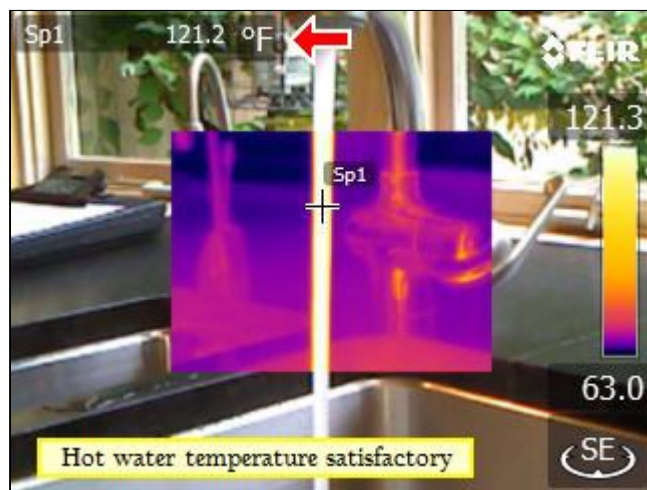
12.8 Picture 1

**12.8** Hot water temperature appears adequate/child safe.

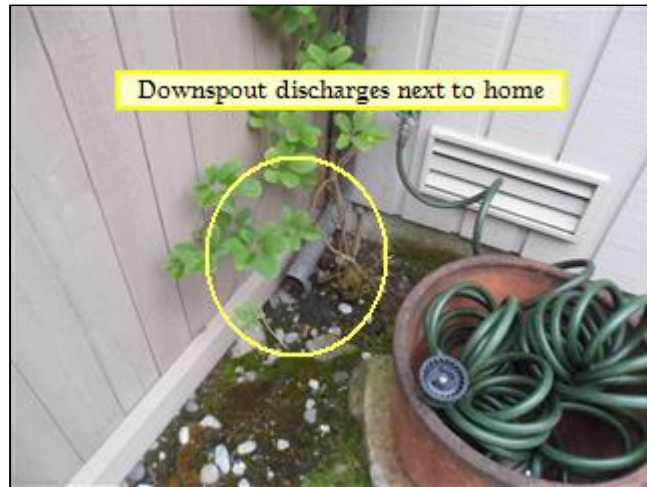
13.2 Picture 1

**13.2 (2) West Copper downspout does not have an inground drain line or splash block; Installation is recommended to divert/control drainage next to home.**

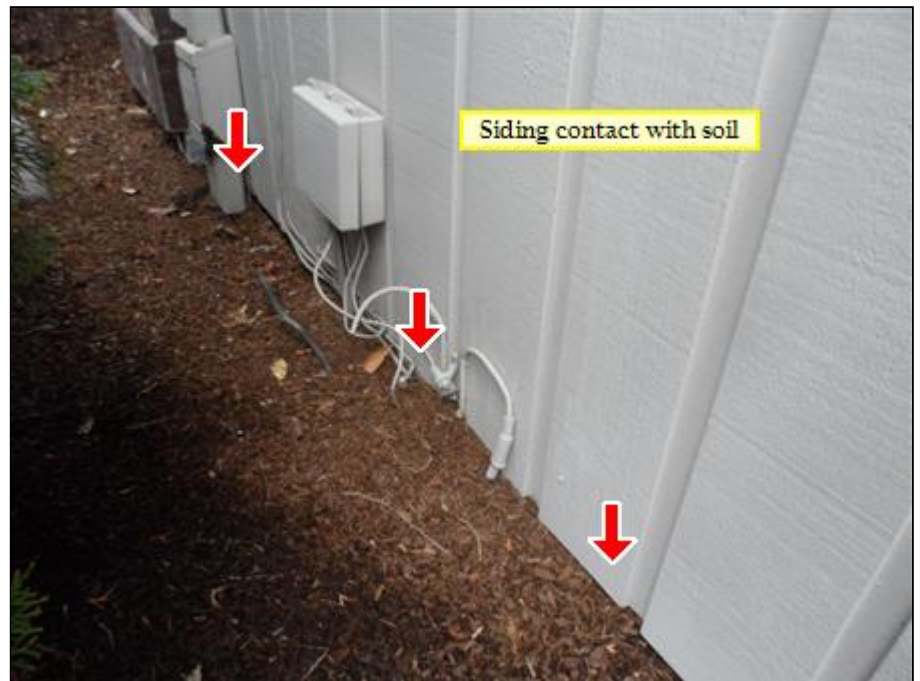
13.3 Picture 1

**13.3 Siding is in contact with soil at multiple areas around home - highly conducive to dry rot/pest damage; Recommend creating a minimum of 6 inches clearance between bottom of siding and grade.**

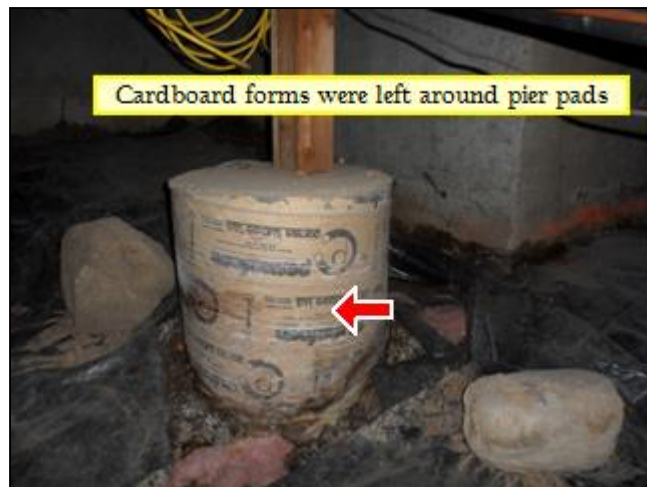
13.15 Picture 1

**13.15 (2)** Builder left carport forms around concrete pier pads - susceptible to mold, decay and pest activity; ***Recommend stripping off/remove all cardboard from forms.***

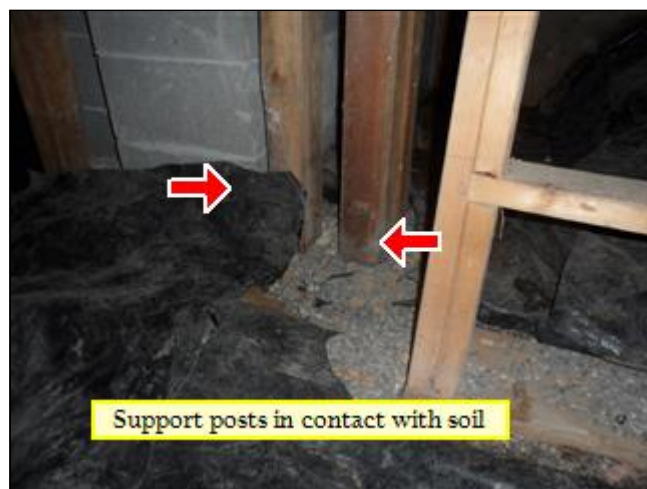
13.15 Picture 2

**13.15 (3)** Several support posts are in contact with soil which is highly conducive to pest damage/dry rot; ***Grade soil away from posts a minimum of 4-6 inches at time of substructure waterproofing.***
